Site Photographs

Exide
Los Angeles Recycling Facility
Los Angeles County, California

Photograph date: 2/16/2011

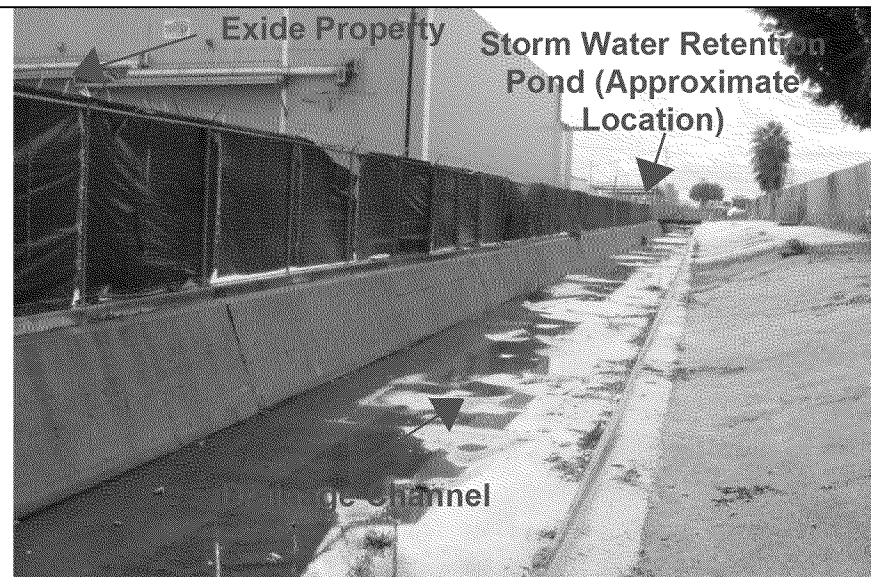
Photograph 1 – View facing southwest at drainage channel that serves as the western border of the northern portion of the Facility.

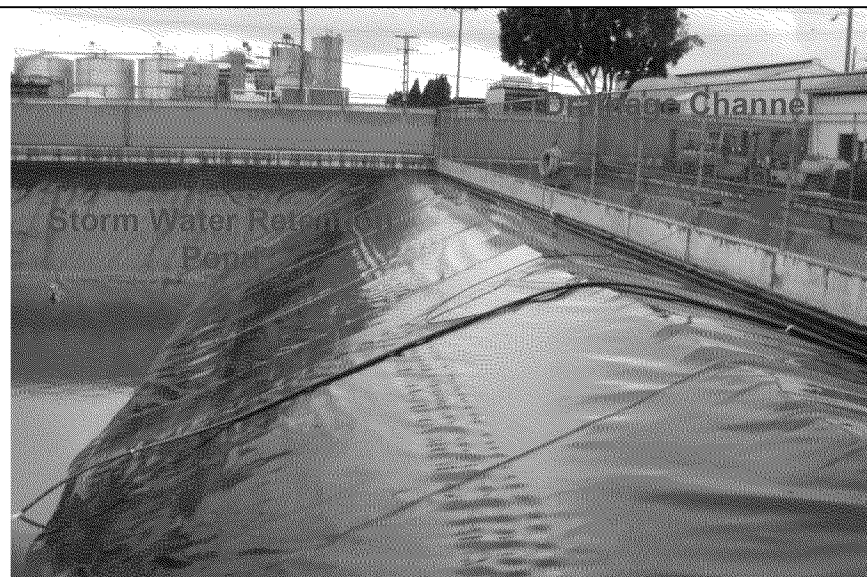
Photograph 2 – View facing southwest at drainage channel that bisects the southern portion of the Facility.

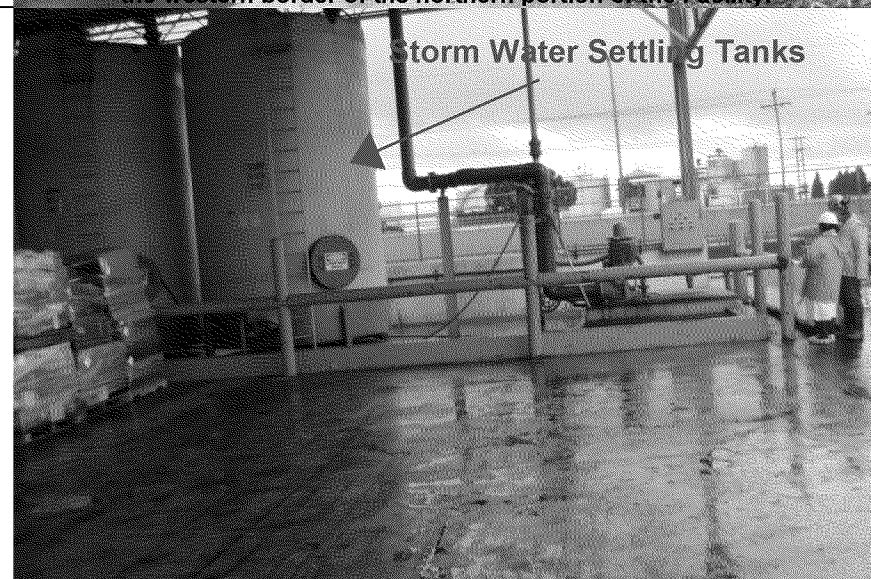
Photograph 3 – Series of four storm water settling tanks (approximately 10,000 gallons each) that are used to feed storm water into the WWTP.

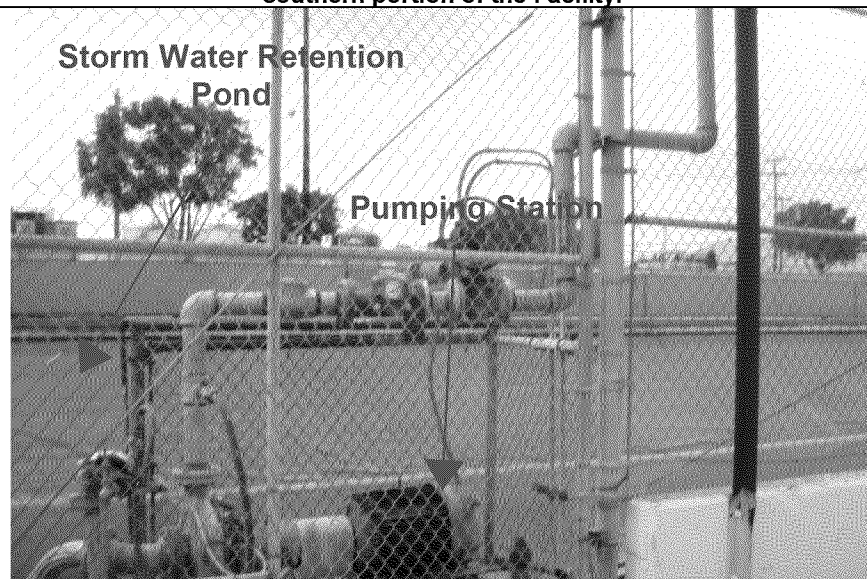
Photograph 4 – A pumping station located near the northeast corner of the storm water retention pond.

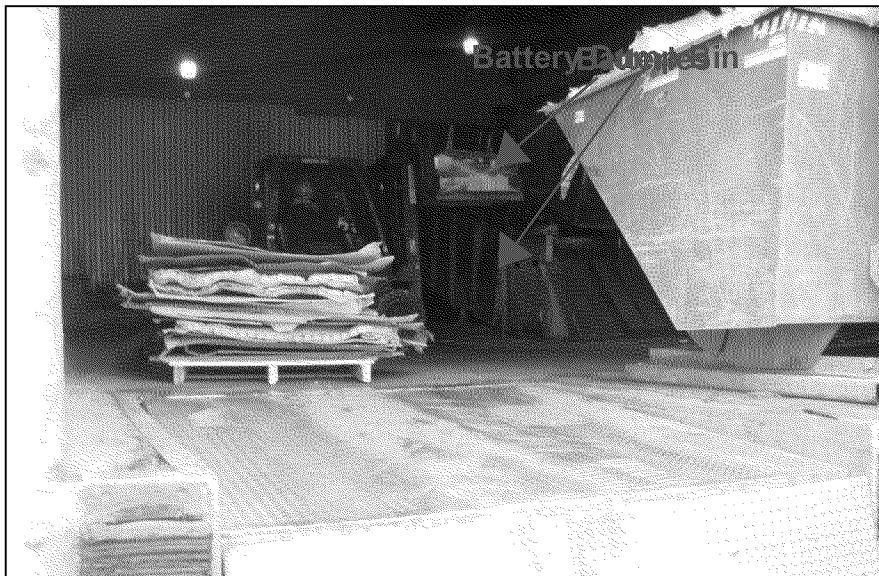
Photograph 5 – View of batteries being placed in the battery dump bin from the battery recycling delivery dock.

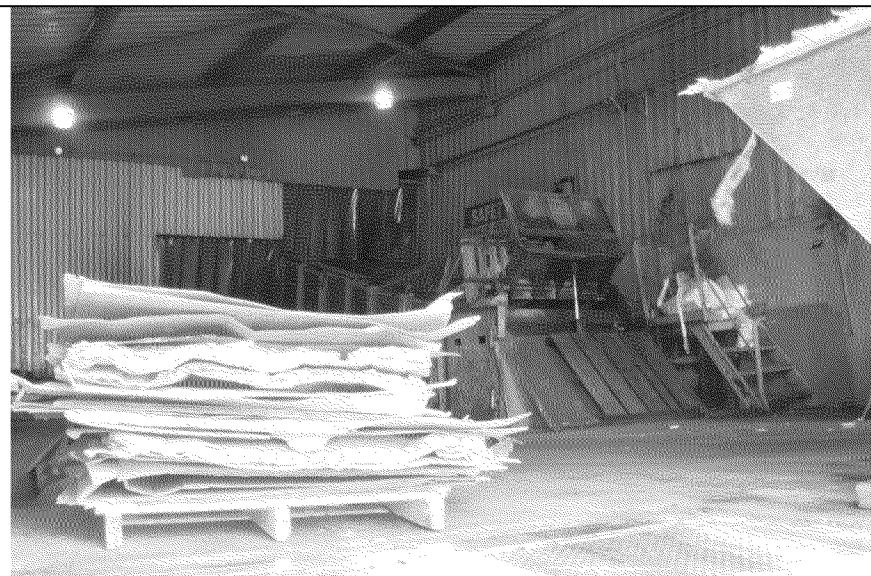
Photograph 6 – View of battery dump bin from the battery recycling delivery dock.

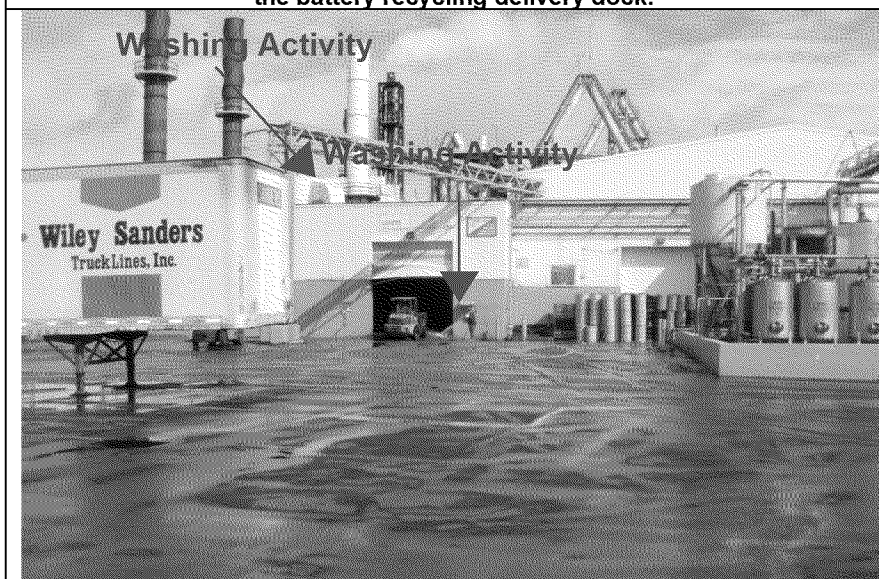
Photograph 7 – View facing north at equipment and pavement washing activity outside the blast furnace feed room.

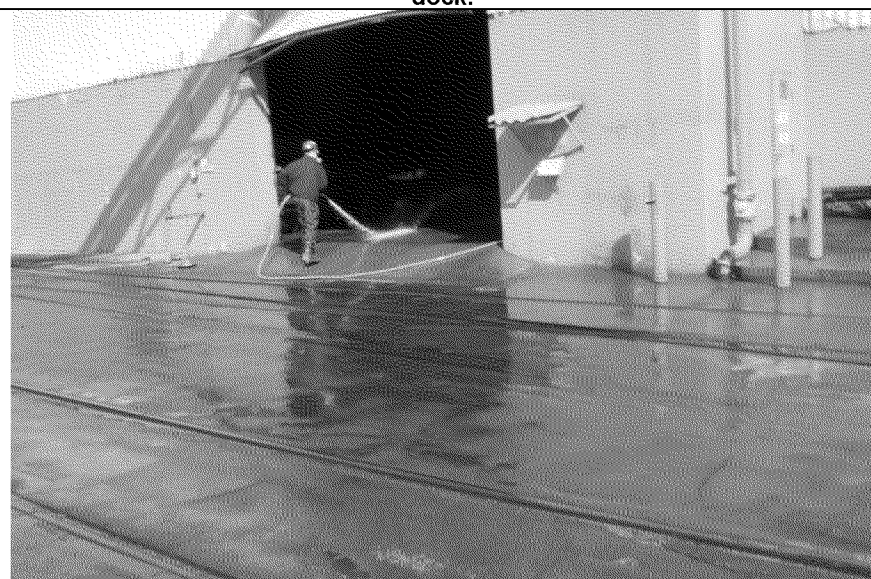
Photograph 8 – Close-up view of washing activity facing northwest.

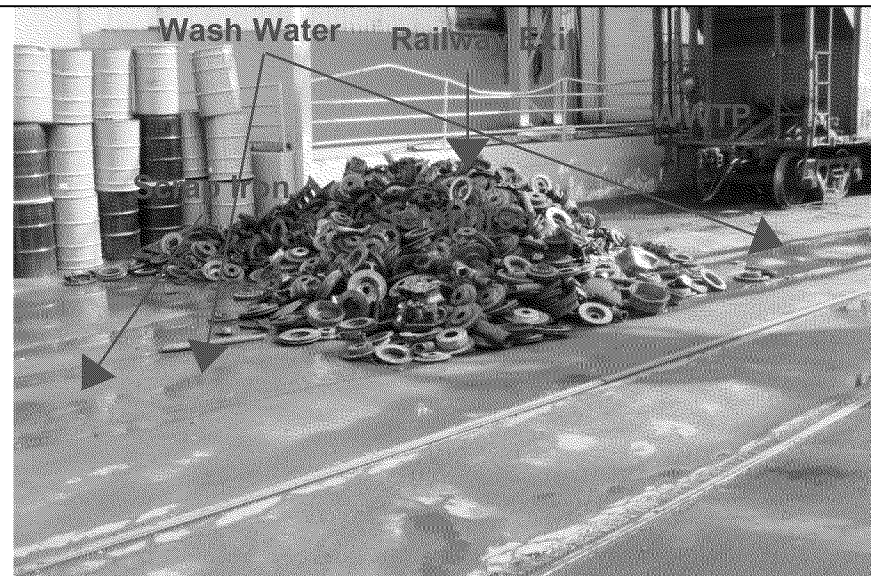
Photograph 9 – View of wash water (shown in Photograph 8) flowing through a scrap iron stockpile, facing east.

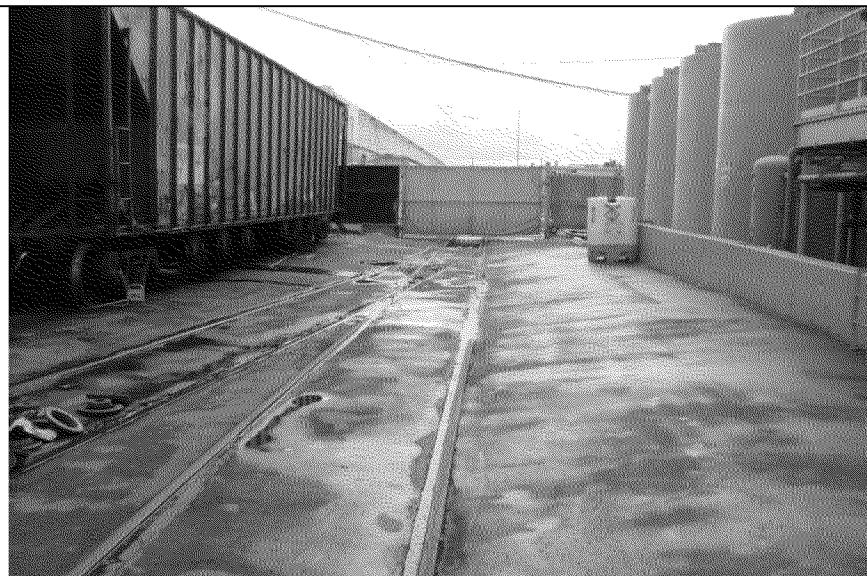
Photograph 10 – View toward the railway exit along South Indiana Street, facing southeast.

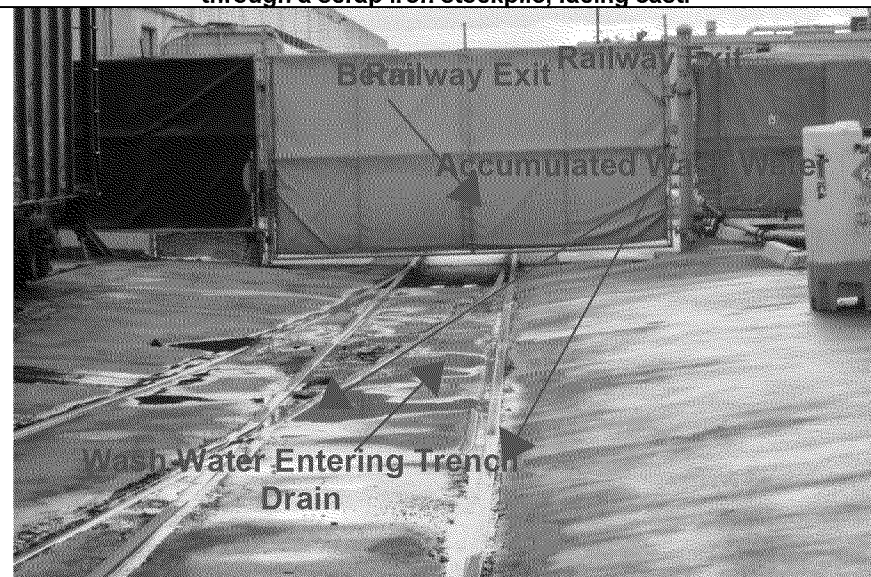
Photograph 11 – Close-up view of accumulated wash water along the tracks, facing southeast.

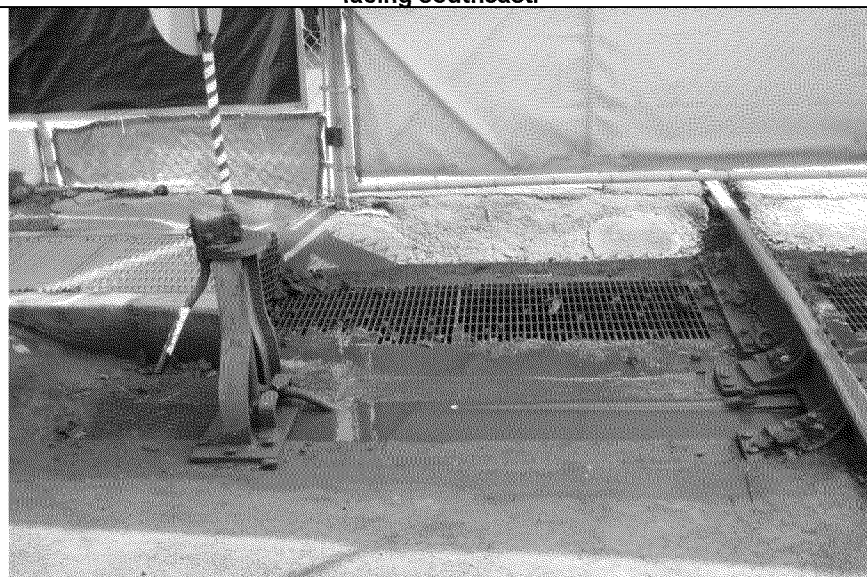
Photograph 12 – View of wash water flowing into the trench drain adjacent to the railway exit, facing southeast.

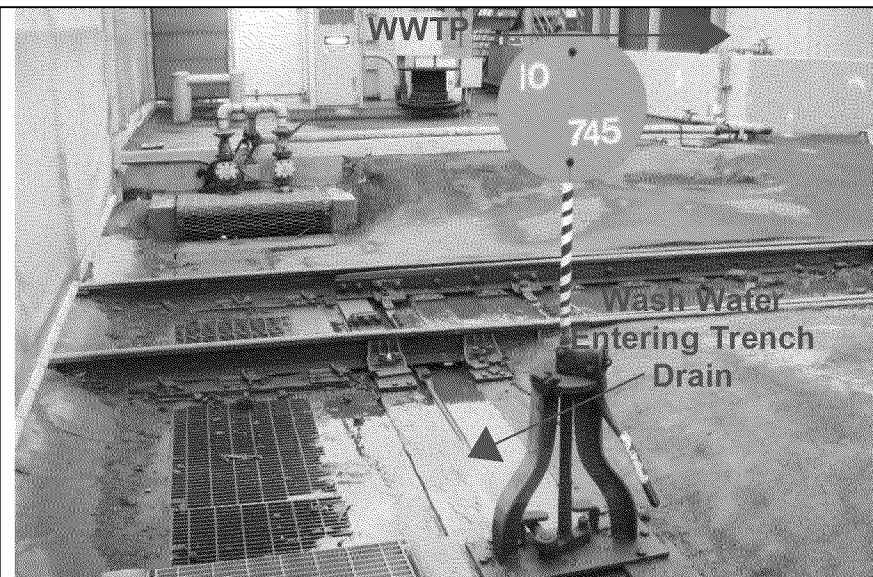
Photograph 13 – View of wash water flowing into the trench drain adjacent to the railway exit, facing southwest.

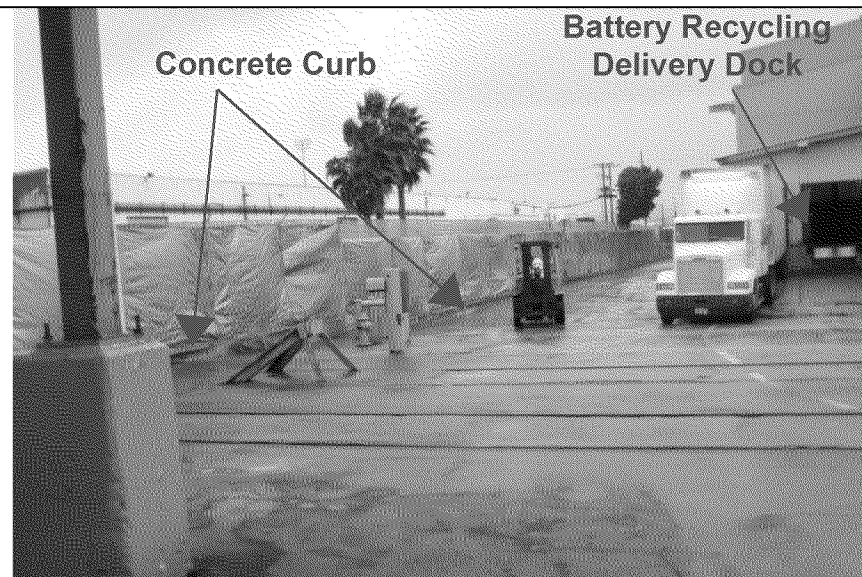
Photograph 14 – View of concrete curb from inside the North Yard, facing northwest.

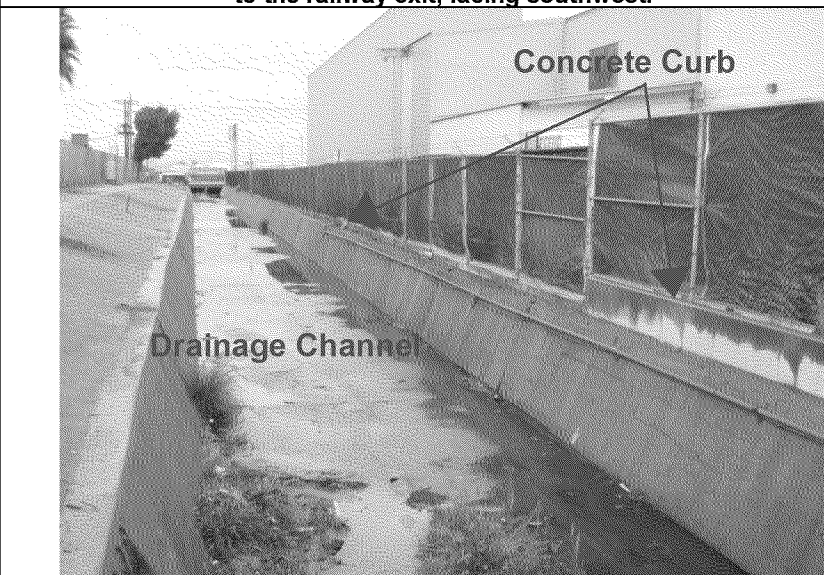
Photograph 15 – View of concrete curb from bridge over the drainage channel in the North Yard, facing north.

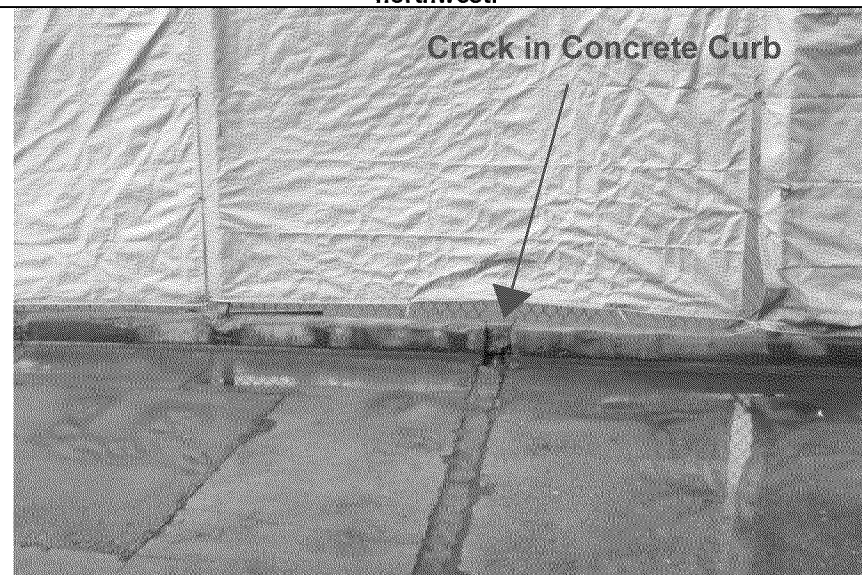
Photograph 16 – View of crack present in the concrete curb adjacent to the battery recycling loading dock, facing west.

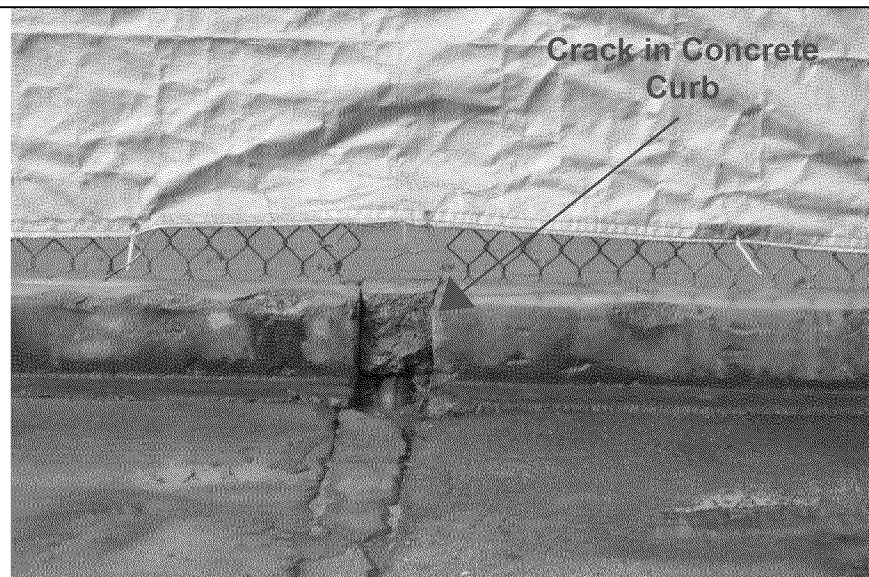
Photograph 17 – Close-up view of crack shown in Photograph 16.

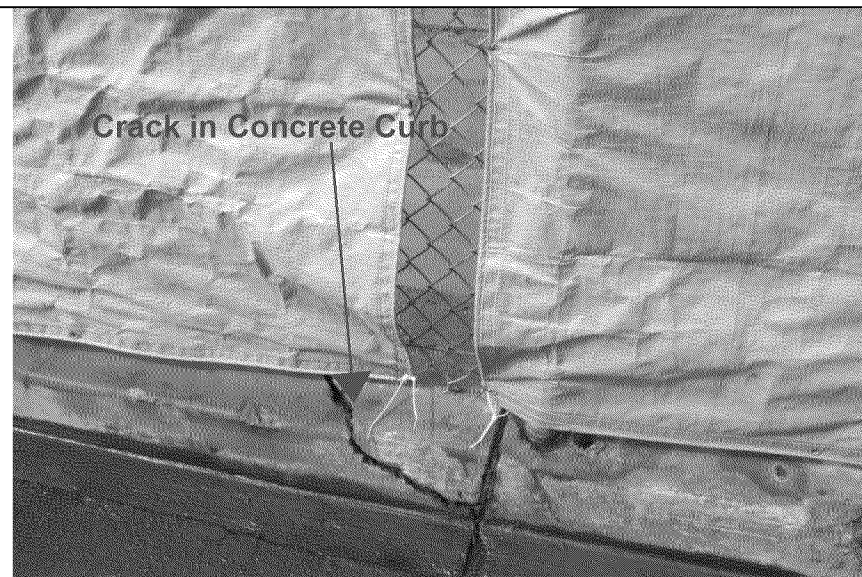
Photograph 18 – View of another crack present in the concrete curb to the north of Photograph 17, facing northwest.

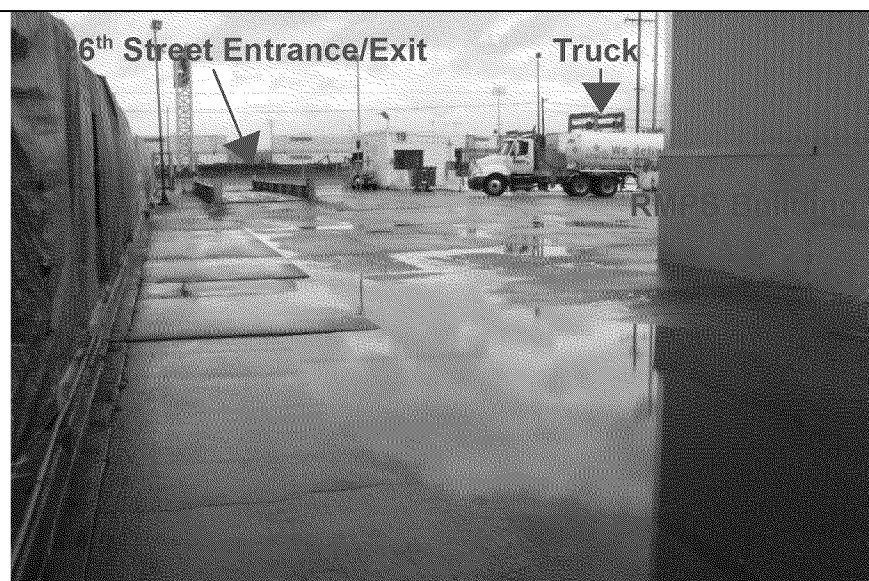
Photograph 19 – View from the west side of the RMPS building facing northeast. Note truck traffic exiting the Facility.

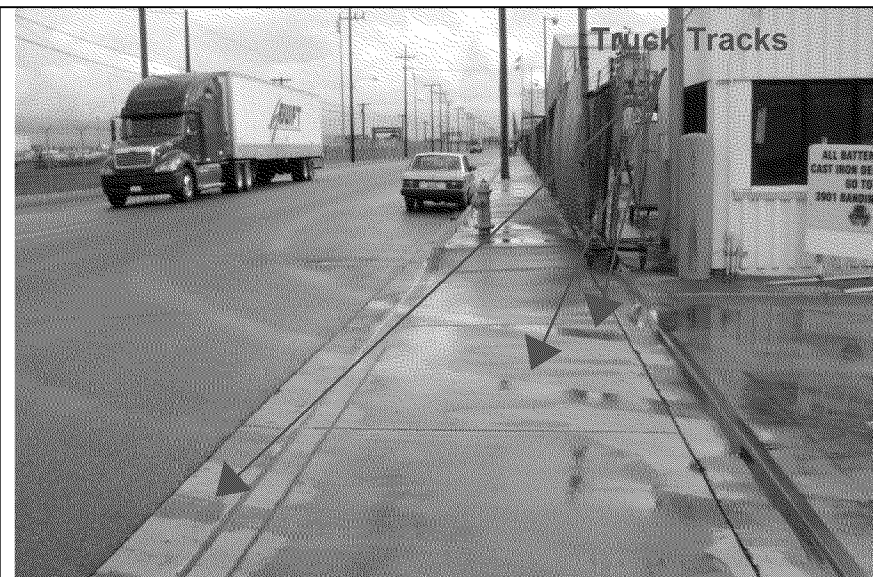
Photograph 21 – View of 26th Street entrance/exit, facing east. Note truck tracks and storm water leading from the Facility.

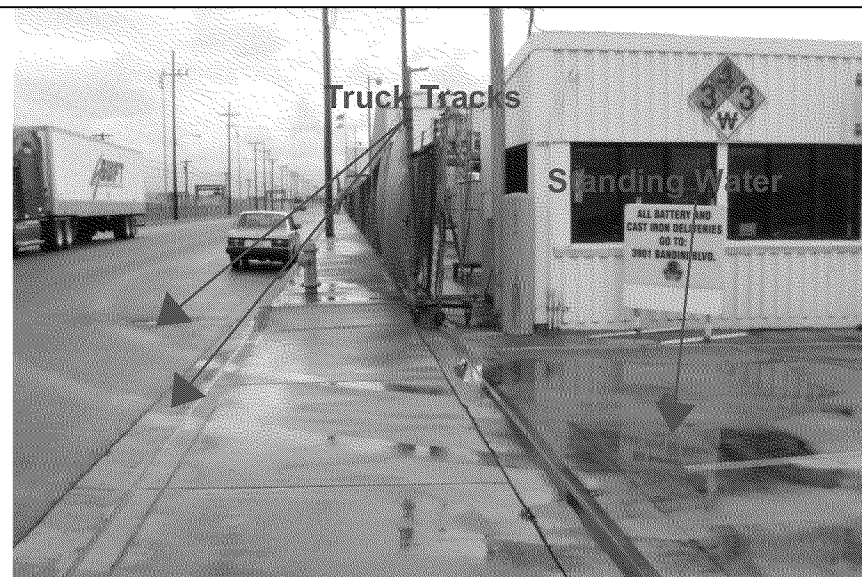
Photograph 22 – View of 26th Street entrance/exit, facing east. Note truck tracks and storm water leading from the Facility.

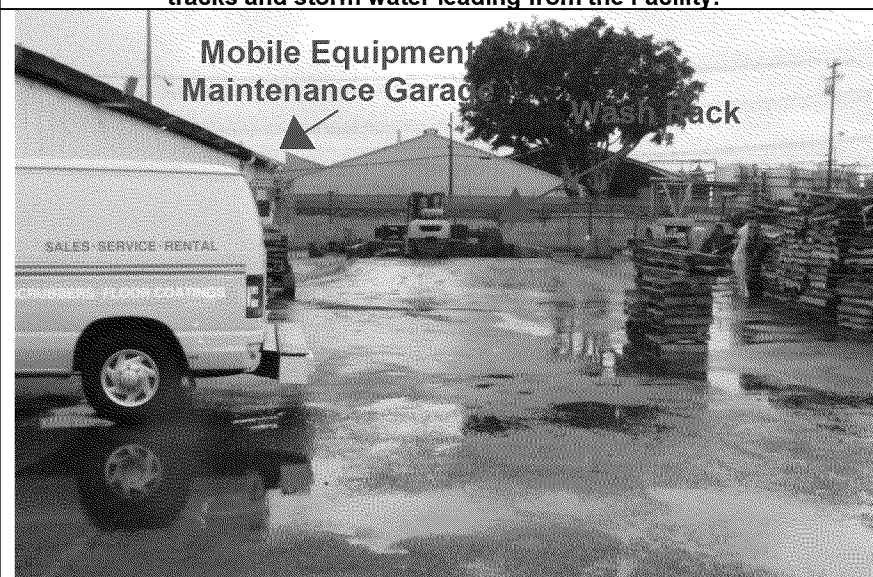
Photograph 23 – Mobile equipment wash rack located to the west of the Mobile Equipment Maintenance Garage, facing south.

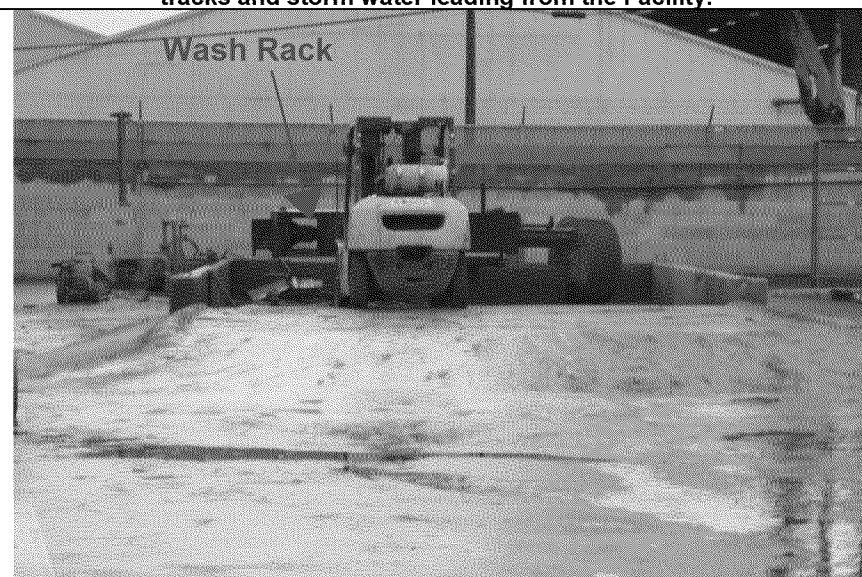
Photograph 24 – Close-up view of mobile equipment wash rack shown in Photograph 23.

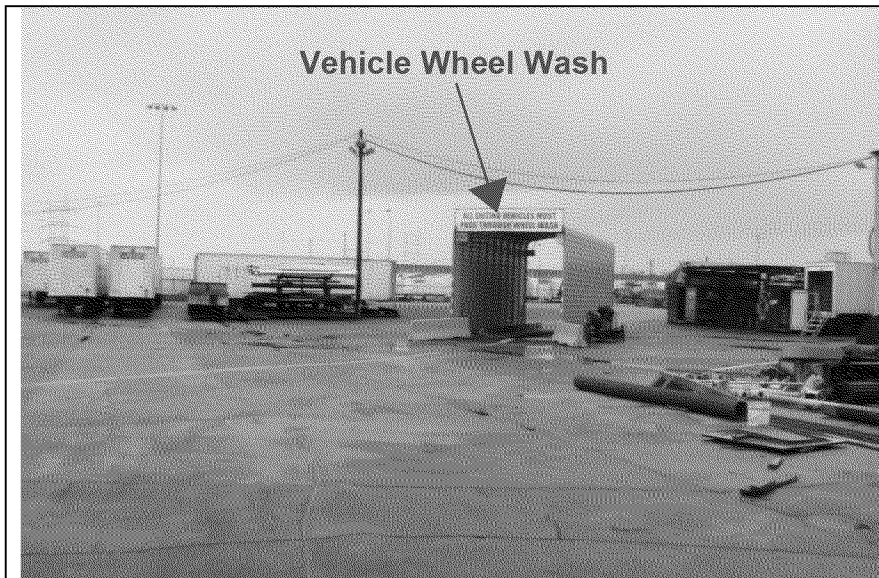
Photograph 25 – Vehicle wheel wash facility northeast of the Bandini Boulevard entrance/exit, facing west.

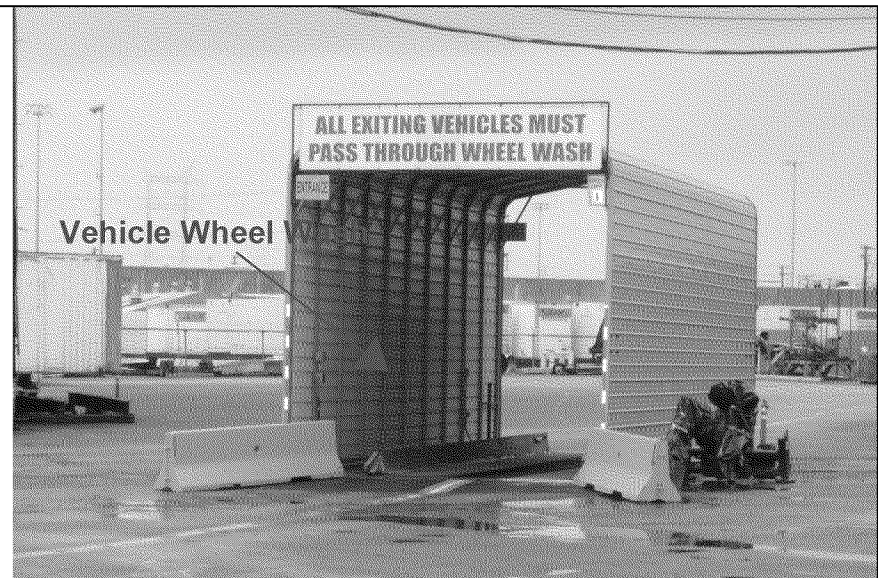
Photograph 26 – Close-up view of vehicle wheel wash facility shown in Photograph 25.
